# BELZONA REPAIRS FLOATING HOSES

ID: 3640

Industry: *Marine*  
Application: *SOS-Ships and Offshore Structures*

Customer Location: *Port authority, Wilhelmshaven, Germany*  
Application Date: *March 2011*

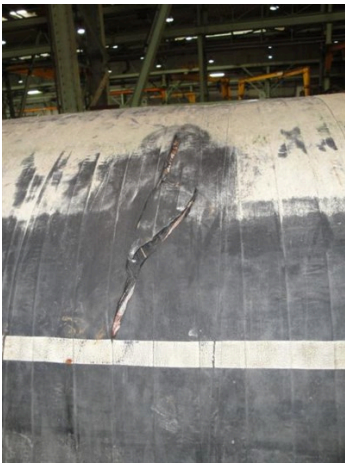
*Dredger damage to the floating hoses.*

- \* Close-up of damage ,
- \* Surface preparation roughening ,
- \* Completed application including use of stainless steel screws to hold the repair in place ,
- \* Performance test (24 hours) ,

The floating hoses were in use at the port and were to be transported to Odessa, Ukraine, for another project. During dredging damage was caused to the outer skin. Only five days were available to repair 6 floating hoses, a replacement was not available. A new hose would have cost 60,000 EURO. In order to meet the strict deadline a specialist company was sought to undertake the repair and prevent future problems associated with the project. As a result of previous co-operation and many years of experience within the marine and dredging industry the Belzona distributor was recommended to undertake the repair. Following 24 hours after the repair comprehensive performance tests were undertaken; the Belzona repair passed successfully.

The repair was carried out using a modified version of SOS-12. Surface preparation consisted of roughening the surfaces prior to the application of Belzona® 2911. A rubber mat was bonded over the damaged area with Belzona® 2211, using stainless steel screws to hold the repair in place.
