# BELZONA REPAIRS BOW THRUSTER

ID: 3642

Bow thruster casing of a cargo ship.

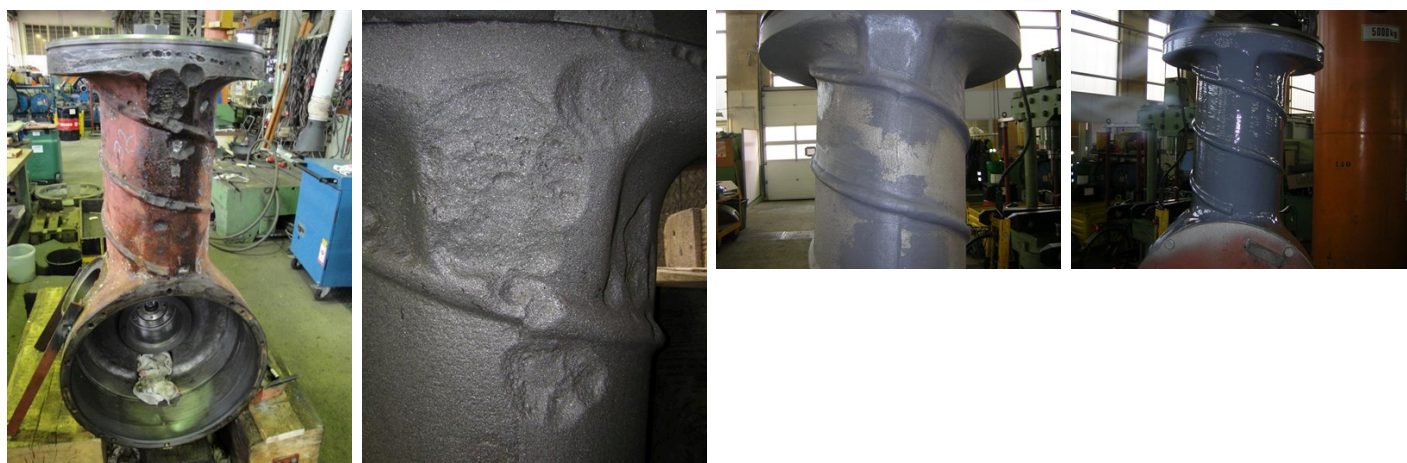
*Extensive damage to the bevel gear system's casing.*

- \* Extensive damage clearly visible ,
- \* Close-up following grit blasting ,
- \* Application in progress ,
- \* Completed application ,

The application was carried out in accordance with Belzona Know-How System Leaflet SOS-2.

and reliable service delivery with the shipyard, shipping line and classification society. Belzona 4311 (Magma CR1) was applied not due to any chemical performance need but because the first inspection by the client is visual, and this extra layer gives a professional, aesthetical finish.
