BELZONA GRIP SYSTEM MAINTAINS BRAKE TEST EQUIPMENT

ID: 3644

Customer Location: *Truck test centre, central Sweden*
Application Date: *February 2012 (it has been done regularly since 2002)*

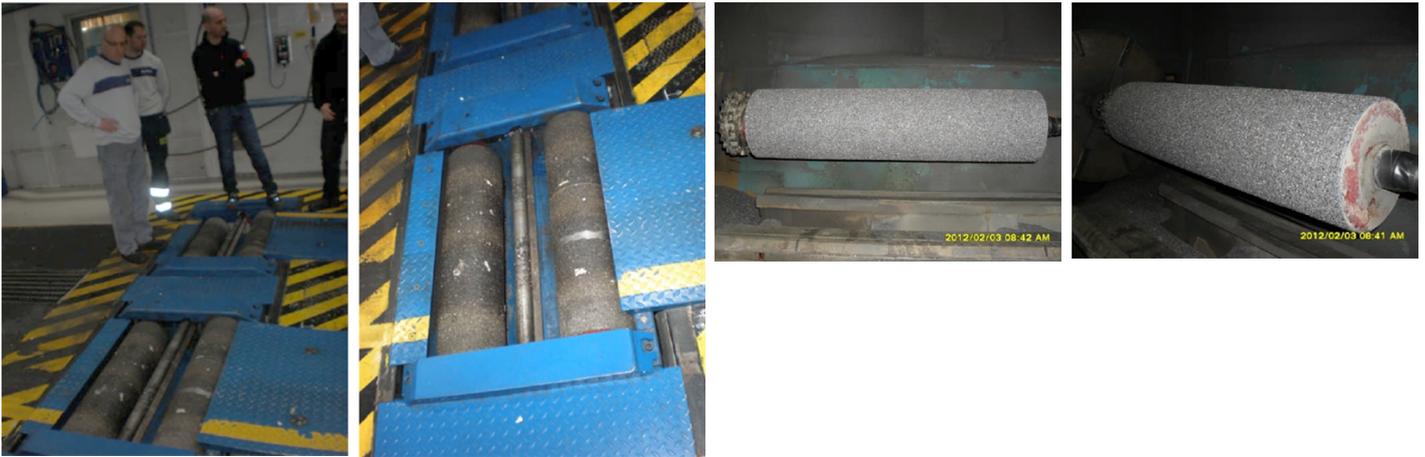
The drive rollers in the brake tester lose their grip and do not have sufficient friction with the tyre to complete an accurate test.

- * Worn rollers in the truck tester ,
- * Close-up of the worn roller ,
- * Roller coated with Grip system of Belzona® 1321 and Silicon carbide aggregate, in the workshop ,
- * Finished application ,

Application carried out in accordance with Belzona Know-How System Leaflet SHM-12.

The customer is happy about the result and the lifetime, which is approximately 4 years.
