BELZONA PROTECTION TO AERZENER LOBE COMPRESSOR

ID: 365

Customer Location: *Steel Mill in Saudi Arabia*
Application Date: *2002*

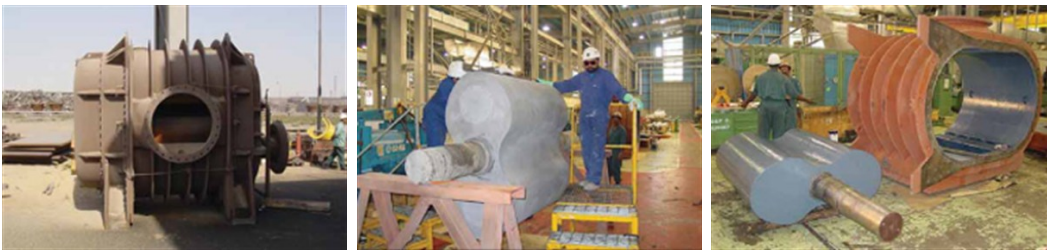
Photograph Descriptions

Hot scrubbed gas contains fine particles which are broken down by spraying with water, this combination causes severe corrosion.

- * General view of compressor ,
- * Work underway on the lobe ,
- * Body and lobe protected with Belzona® 1391 ,

Application was carried out using a modified version of Belzona System Leaflets PDP-4, FBC-2 and FBC-5. Pitting damage repaired with Belzona® 1111 and internal casing and lobe protected with Belzona® 1391.
