BELZONA REPAIR TO OIL COOLER

ID: 366

Customer Location: Power Station in Sri Lanka
Application Date: January 2001

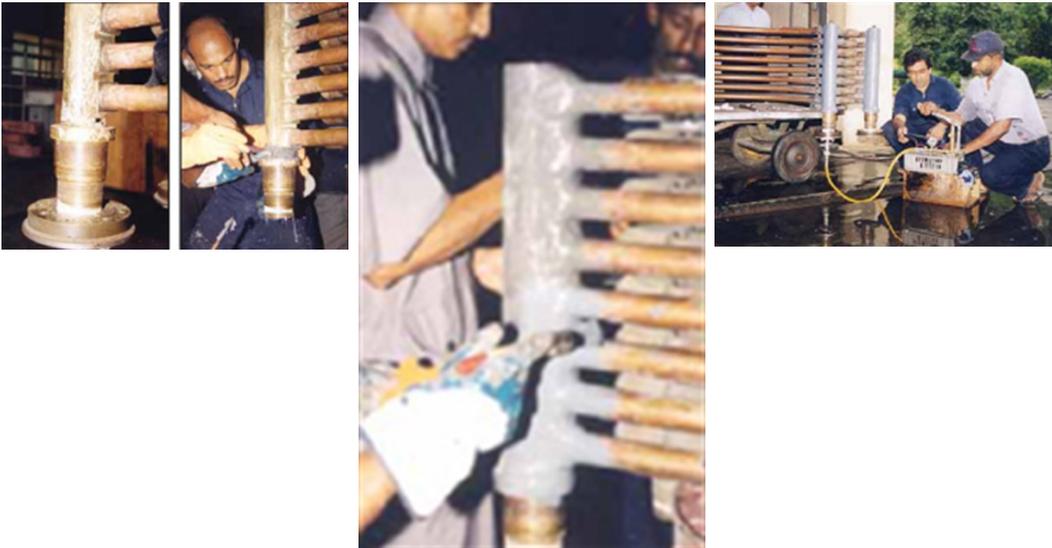
Photograph Descriptions

The unit was severely damaged and leaking as a result of bimetallic corrosion.

- * Corroded unit with holes clearly visible - Belzona® 1111 being used to repair holed and corroded areas ,
- * Belzona® 1321 being applied to protect unit ,
- * Completed application being pressure tested ,

Application was carried out using techniques adapted from Belzona System Leaflets HEX-3 & HEX-9. Holed and corroded areas were rebuilt using Belzona® 1111 incorporating Belzona® 9341 (Reinforcement Tape).

Unit was pressure tested before being returned to service and has regularly been inspected since and remains in perfect condition. Belzona repair was carried out at a fraction the cost of a replacement unit.
