# BELZONA PREVENTS GALVANIC AND CREVICE CORROSION ON RUDDER HORN

ID: 367

Industry: *Marine*  
Application: *SOS-Ships and Offshore Structures*

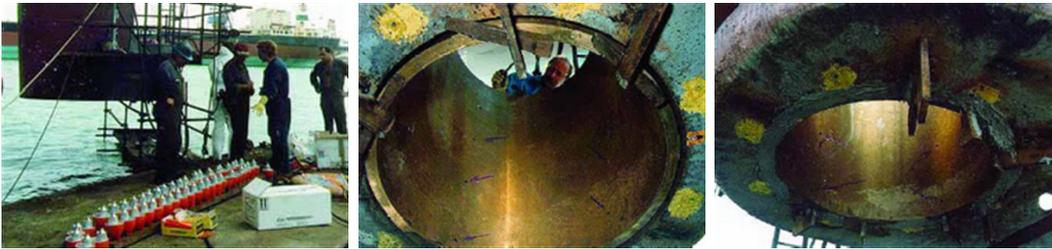
*Corrosion to internal of rudder horn had allowed the press fitted bronze bearing to become free. Bearing was approximately 908-mm (36-inch) diameter and 1050-mm (41-inch) long.*

- \* Belzona materials and team prepared for application. ,
- \* Internal shot of bearing. Note arrows for injection ports. ,
- \* Bearing after injection and prior to cleaning up of the Belzona® 1211 seal. ,

The bearing was aligned and its position in the housing fixed using alignment bolts. The top and bottom of the housing were sealed using Belzona® 1211, then Belzona® 1321 was injected from below.

This method is used both in new-build and repair, and this example illustrates the ability to undertake this work while the vessel is afloat. Use of Belzona materials isolates and permanently fixes the bearing into position preventing galvanic and crevice corrosion.
