# BELZONA EMERGENCY IN A COOLING TOWER

Industry: *Power*  
Application: *TCC-Tanks and Chemical Containment Areas*  
Substrate: *Concrete*  
Products: *\* Belzona® 3121 (MR-7) ,*

Customer Location: *Power Plant in Northwest Florida, USA*  
Application Date: *December 1996*

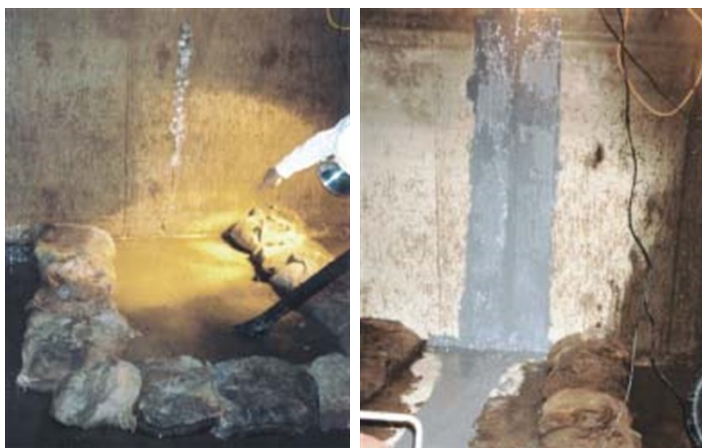
*Crack (leak) in the containment wall and floor.*

- \* The leak; sand bags used to hold back as much water as possible ,
- \* The completed repair ,

The application was carried out in accordance with a modified version of Belzona Know-How Leaflet TCC-1.

The repair was performed overnight and the plant was operational early the next morning. It is estimated that the plant saved \$6,000 in water cost alone.
