# BELZONA EXPANSION JOINTS: TOUGH ENOUGH FOR HEAVILY TRAVELLED HIGHWAYS

Customer Location: Kentucky DOT (Department of Transportation) - U.S.A.

Bridge expansion joints on Interstate 65.

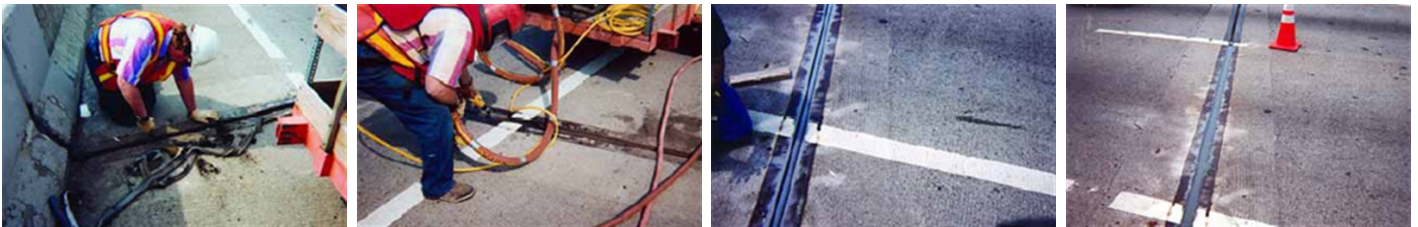
## Photograph Descriptions

The conventional expansion joints were too soft and could not withstand typical road debris. They were failing after less than one year.

- \* The failed joint is easily removed thanks to poor adhesion ,
- \* The surface for the new joint is prepared ,
- \* Backer rod inserted ,
- \* The application is complete and ready for vehicular traffic ,

Application was carried out in accordance with Belzona Know-How System Leaflet FPA-6.

The failing conventional joints were also allowing solutions of calcium chloride and salt to seep through and damage the structural beams. The Belzona solution prevents this from occurring, and has performed perfectly since installation.
