BELZONA PROTECTS PLATFORM LEG

Customer Location: Offshore oil platform, Tianjin-China.

Application: SOS-Ships and Offshore Structures

Products: Belzona 1161 (Super UW-Metal), Belzona 5831 (ST-Barrier)

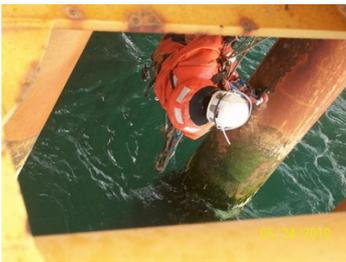
Surface Preparation by MBX
Bristle Baster

Application was carried out in accordance with Belzona Know-How System Leaflets SOS-20a and SOS-20b. The surface was prepared as thoroughly as possible with an MBX Bristle Blaster being used above the water line. The surface preparation and application of Belzona® 1161 had to be carried out using rope access and divers.

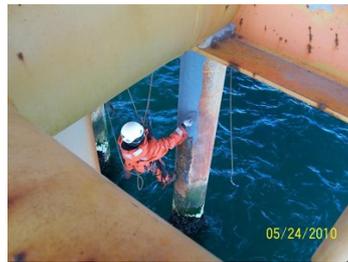
Belzona 1161 being applied

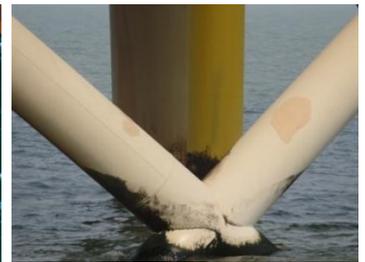
Inspection after 7 years in
service

The surface tolerant properties of Belzona® 5831 made it the ideal solution for these difficult access conditions. The product provides excellent adhesion to surfaces both in the splash zone and underwater. Application inspected in 2017 after seven years in service and found to be providing excellent corrosion protection.
