BELZONA PROTECTS PLATFORM LEG

Customer Location: Offshore oil platform, Tianjin-China.

Application: SOS-Ships and Offshore Structures

Products: Belzona 1161 (Super UW-Metal), Belzona 5831 (ST-Barrier)

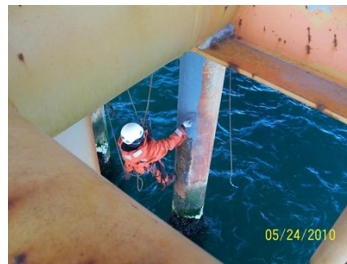
Belzona 1161 being applied

Application was carried out in accordance with Belzona Know-How System Leaflets SOS-20a and SOS-20b. The surface was prepared as thoroughly as possible with an MBX Bristle Blaster being used above the water line. The surface preparation and application of Belzona® 1161 had to be carried out using rope access and divers.

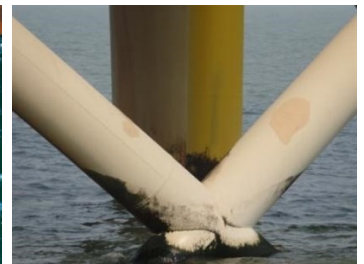
Inspection after 7 years in
service

The surface tolerant properties of Belzona® 5831 made it the ideal solution for these difficult access conditions. The product provides excellent adhesion to surfaces both in the splash zone and underwater. Application inspected in 2017 after seven years in service and found to be providing excellent corrosion protection.
