BELZONA REPAIRS DAMAGED RISER CLADDING

ID: 3719

Industry: Oil & Gas
Application: SOS-Ships and Offshore Structures

Customer Location: Offshore oil production platform, China
Application Date: April 2006

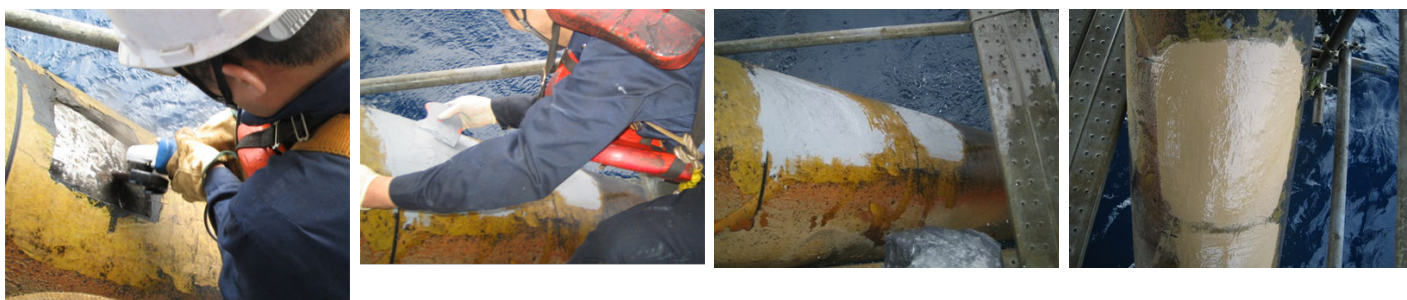
Photograph Descriptions

The riser cladding was damaged due to abrasion. This needed repairing before corrosion compromised the integrity of the riser.

- * Surface preparation with a disc grinder ,
- * Application of Belzona 1161 ,
- * Cladding profile restored with Belzona 1161 ,
- * Completed application after application of Belzona 5831 ,

Damaged cladding on riser.

Application was carried out using a modified version of Belzona Know-How System Leaflet SOS-21. After surface preparation with a disc grinder, Belzona 1161 was used to rebuild the damaged area before overcoating with Belzona 5831 to protect the riser from further corrosion.
