BELZONA AIR HANDLING FAN & SHROUD

ID: 373

Application: *FBC-Fans, Blowers and Compressors*

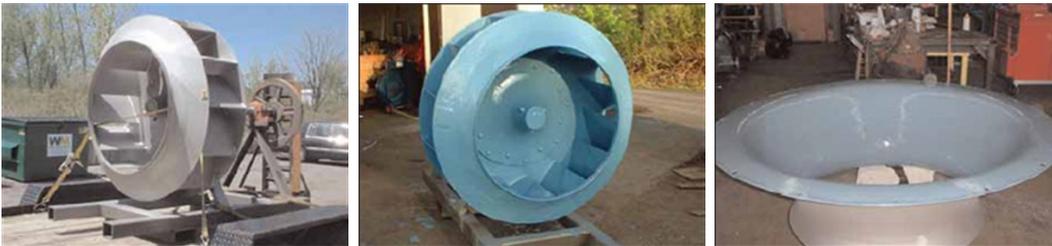
Photograph Descriptions

Fan was constantly going out of balance due to particulate sticking to the blade.

- * Fan blasted to 3-4 mil profile, white metal finish ,
- * Second coat of Belzona® 1341 completed on fan ,
- * Shroud coat completed ,

The Application was carried out in accordance with Belzona Know-How System Leaflet FBC-2.

The fan was dynamically balanced before and after the application.
