BELZONA EXCELS WHERE OTHERS FAIL!

ID: 375

Application: *MPT-Mechanical Power Transmission*

Forging Machine Cam

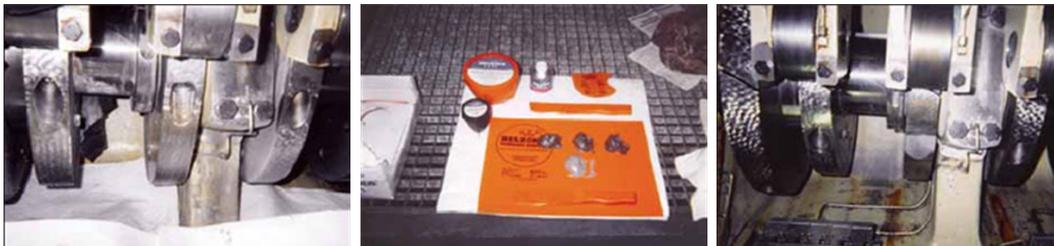
Photograph Descriptions

Forging machine cam failed, imitator product failed in one week.

- * The Cam ,
- * Products being used ,
- * The completed application ,

The application was carried out in accordance with a modified version of Belzona Know-How Systems Leaflet MPT-12. Damaged areas were ground down. Following degreasing, Belzona® 1111 was applied, then ground/sanded back to profile.
