BELZONA REFORMS CLARIFIER SHAFT

ID: 3758

Industry: Water / Wastewater
Application: MPT-Mechanical Power Transmission

Customer Location: Water treatment plant, Bilbao, Spain
Application Date: June 2012

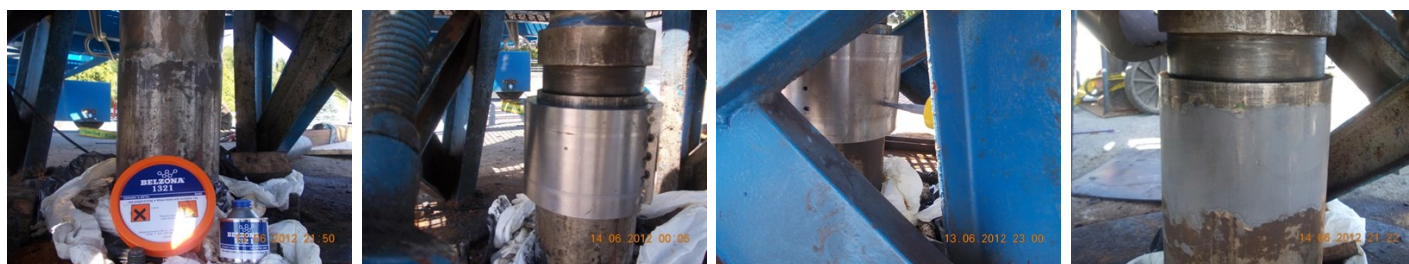
Photograph Descriptions

The damaged shaft had to be repaired but it could not be dismantled so an in-situ repair was required.

- * Shaft before application ,
- * Former in place ,
- * Injection of Belzona® 1321 in progress ,
- * Rebuilt shaft ,

Vertical shaft of clarifier. 6 meters length and 20 centimetres diameter

The application was carried out in accordance with the Belzona Know-How System Leaflet MPT-2. The shaft diameter was reformed using a pre-made former and injecting Belzona® 1321.

As a result of the application using a forming technique, the shaft could be repaired in situ without dismantling it, minimising downtime and disruptions to the client's facilities and operations.
