# BELZONA INCREASES EFFICIENCY OF COOLING WATER PUMPS

**Industry:** General Industry  
**Application:** CEP-Centrifugal Pumps  
**Substrate:** Cast Iron  
**Products:** \* Belzona® 1311 (Ceramic R-Metal) ,  
\* Belzona® 1341 (Supermetalgilde) ,

**Customer Location:** Steel Mill, Hungary  
**Application Date:** January 2010

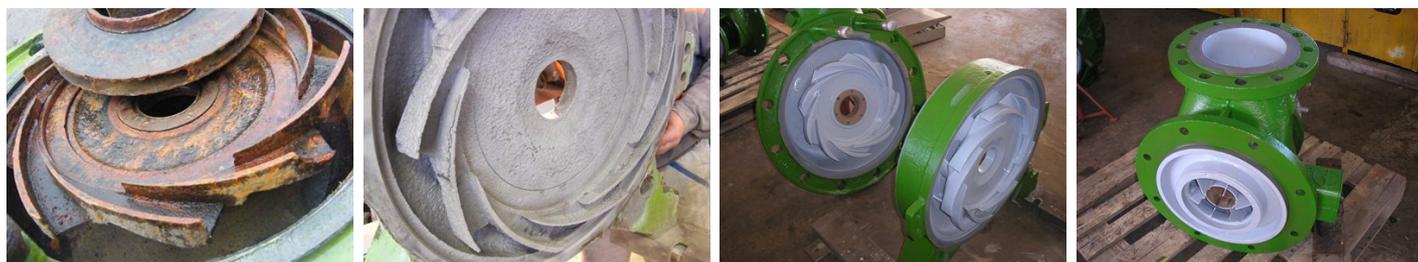
Traces of cavitation, corrosion damage as well as material loss found on the wetted surfaces of the pump. It was necessary to rebuild and coat the inlet, casing and suction cover with Belzona erosion-corrosion resistant products to restore efficiency.

- \* Before application ,
- \* After grit blasting ,
- \* Rebuilt and coated pump ,
- \* Finished application ,

After installation the operating parameters of the pump were excellent; the power consumption reduced by 10-12%, from 270-280 amp prior repair to 240-250 amp. The operating pressure increased from the previous 8-8.5 bar to 9-9.5 bar and the flow rate increased from 400 m<sup>3</sup> to 450 m<sup>3</sup>. This means the repaired pumps performance corresponds to the manufacturer's original parameters.
