BELZONA PROTECTS PLATFORM LEG ABOVE AND BELOW WATERLINE

ID: 3761

Customer Location: Offshore production platform, Adriatic Sea.

Application: SOS-Ships and Offshore Structures

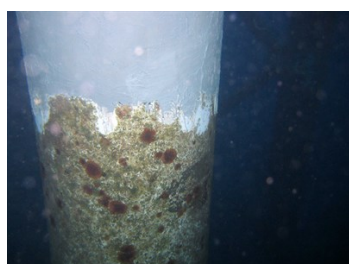
Due to constant immersion in seawater the platform leg in the splash zone was suffering from corrosion and needed protecting.

* Damage before coating was applied 1st coat of Belzona® 5831 applied Completed application with 2nd coat of Belzona 5831 applied Excellent condition of coating when examined in 2012 ,

Application was carried out in accordance with a modified version of Belzona Know-How System Leaflet SOS-21. After manually preparing the surface the Belzona® 5831 was applied in two coats to the corroded areas above and below the waterline. Application was completed by divers in the water.

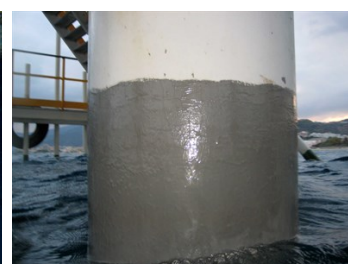
to this type of repair where access for surface preparation and application is restricted. Inspected in 2012 the coating was still providing excellent corrosion protection.
