# BELZONA REPAIRS 24" PIPE ELBOW

ID: 382

**Customer Location:** Petrochemical Plant, Kuwait  
**Application Date:** 2001

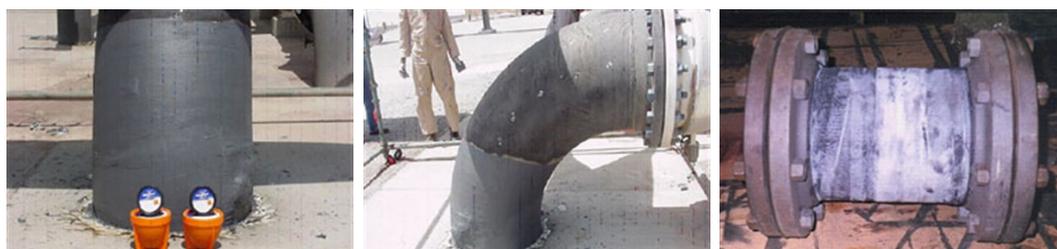
Failure of the internal lining had lead to wall thinning and a through wall defect. NDT was used to define the thinned area.

- \* Front view ,
- \* Side view ,
- \* Test piece being prepared for evaluation ,

A steel patch was welded into position in the area of the through wall defect. A base layer of Belzona® 1311 was applied followed by Belzona® 9341. The whole process was then repeated and a layer of Belzona® 1311 applied to give a smooth finish.

This repair was evaluated extensively by the maintenance team prior to being undertaken. Defects were ground into pipespools and the pipespools were then wrapped in the manner described above. These were then successfully pressure tested prior to undertaking the actual repairs.
