# BELZONA KEEPS THE BREAD DOUGH DRY

**Industry:** General Industry  
**Application:** RPA-Roof Problem Areas  
**Substrate:** Coated Foam/Built-up Areas  
**Products:** \* Belzona® 3111 (Flexible Membrane) ,  
\* Belzona® 3921 (GSC Surface Conditioner) ,

**Customer Location:** Bakery in Abilene, Texas, U.S.A.  
**Application Date:** September 2002

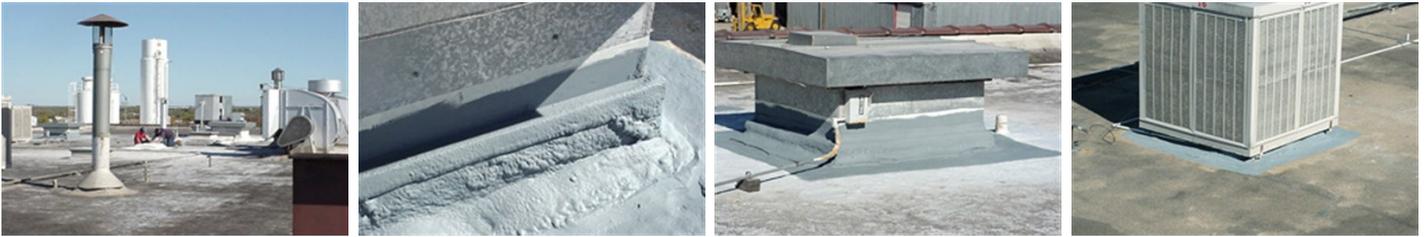
Sun, heat and age led to the roof coating becoming cracked and blistered in areas, allowing water to leak into the building.

- \* View of roof with work in progress. ,
- \* Close-up of blistered/cracked coating being sealed with the Belzona® 3921 (GSC Conditioner) and Belzona® 3111 (Flexible Membrane) System. ,
- \* Roof problem area sealed. ,
- \* Other problem areas were sealed. ,

Before proceeding with the application a test patch was done to a small leak over the general manager's office. The surface was roughened, Belzona® 3921 applied and a two-coat, fully reinforced Belzona® 3111 (Flexible Membrane) system installed. After three rainfalls and two months with no leaks, approval was given to address 500 square feet of problem areas. The coated areas of the roof are perfect.
