# BELZONA SAFETY GRIP SYSTEM ON STAIRS

ID: 3879

Customer Location: *Manufacturer, UK*  
Application Date: *July 2012*

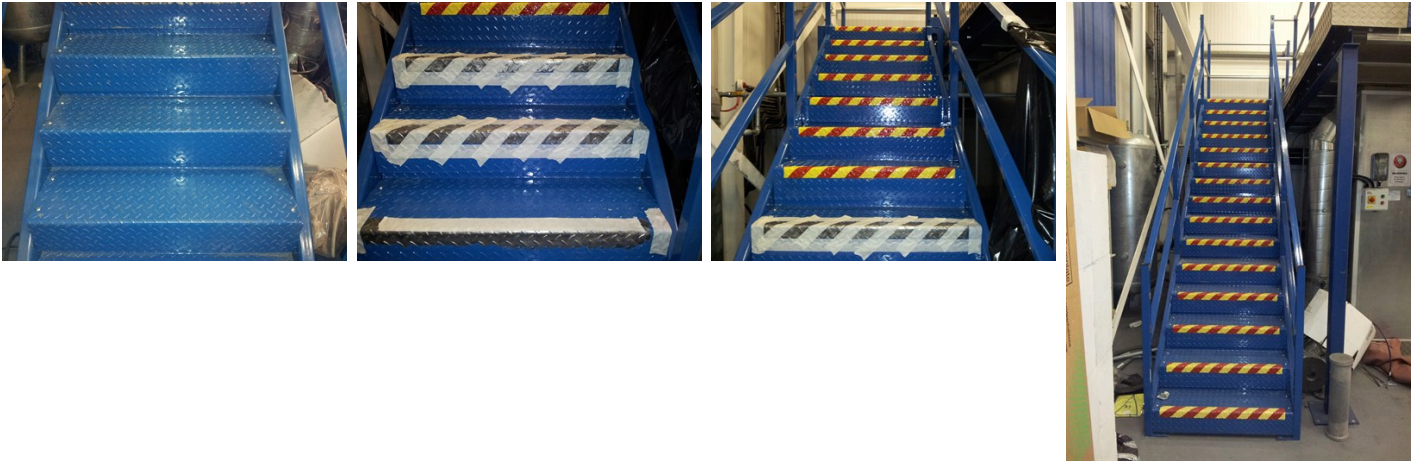
*A potential slip hazard was identified on the metal stairs.*

- \* Steps before Belzona Application ,
- \* Abraded and Masked steps ,
- \* Half of steps completed ,
- \* Completed application ,

Metal stairs leading to a mezanine floor area.

Application was carried out in accordance with Belzona Know-How System Leaflet FPA-8. After preparing the area with an MBX Bristle Blaster stripes of Belzona® 4411 red and yellow safety colours incorporating Belzona® 9221 aggregate were applied.

Belzona® 4411 gave a quick and easy solution to removing a slip hazard from a busy set of stairs. The non-slip properties of the

Belzona Grip system are ideal for this dusty environment and safety colours aide in both identifying the step edges and in highlighting the potential hazard.
