# BELZONA SAFETY GRIP SYSTEM ON STAIRS

ID: 3879

Customer Location: Manufacturer, UK  
Application Date: July 2012

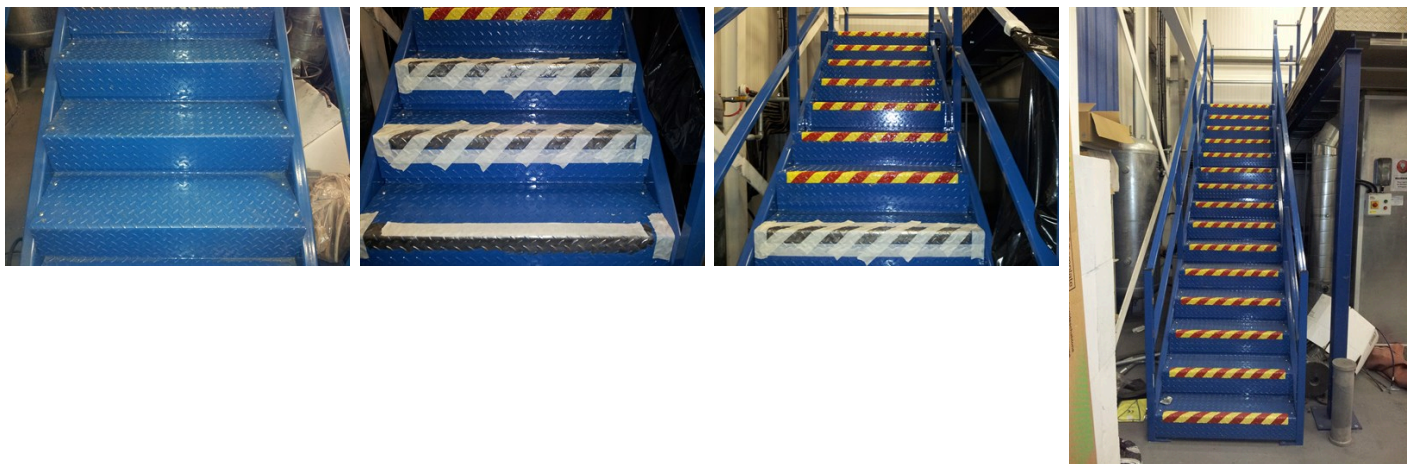
*A potential slip hazard was identified on the metal stairs.*

- \* Steps before Belzona Application ,
- \* Abraded and Masked steps ,
- \* Half of steps completed ,
- \* Completed application ,

Metal stairs leading to a mezanine floor area.

Application was carried out in accordance with Belzona Know-How System Leaflet FPA-8. After preparing the area with an MBX Bristle Blaster stripes of Belzona® 4411 red and yellow safety colours incorporating Belzona® 9221 aggregate were applied.

Belzona® 4411 gave a quick and easy solution to removing a slip hazard from a busy set of stairs. The non-slip properties of the

Belzona Grip system are ideal for this dusty environment and safety colours aide in both identifying the step edges and in highlighting the potential hazard.
