BELZONA PROVIDES SOLUTION TO LEAKING HOSPITAL ROOF

Customer Location: Hospital, Leeds, UK
Application Date: March 2011

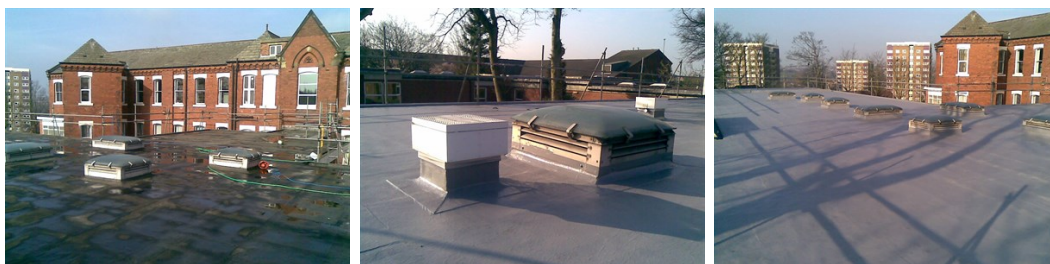
Photograph Descriptions

The felt roofing system had become porous over time and was allowing water into the building below. This was causing major disruption to the operation of the hospital as well as posing a health & safety risk.

- * Image of roof prior to application ,
- * Sealing around skylights and extraction unit ,
- * Completed application ,

Application was carried out in accordance with Belzona Know-How System Leaflet RPA-8. The entire roof was thoroughly cleaned to remove moss and lichens before applying a fully reinforced Belzona® 3131 System.
