BELZONA IS FOR ROOF PROBLEM AREAS

ID: 389

Customer Location: *Manufacturer of fine decorative metal art work in Santa Fe, New Mexico U.S.A.*

Application: *RPA-Roof Problem Areas*

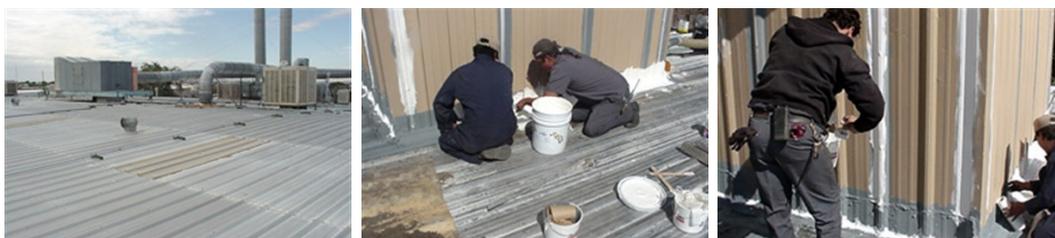
Photograph Descriptions

Heat, UV light, and pollution from the foundry below created water leaks on the roof mending joints, seams, standing water areas and flashings.

- * View of the roof. ,
- * Flashing being sealed with the system. ,
- * Vertical seams are sealed. ,

The application was carried out in accordance with Belzona Know-How System Leaflets RPA-1, RPA-6 and RPA-8.

The Belzona System was used to seal all leaks. After several years there are no leaks and the system is in perfect condition.
