BELZONA PROTECTS PIPELINE FROM MILLSCALE WEAR

ID: 3890

Customer Location: Steel plant, South of France
 Application Date: September 1990

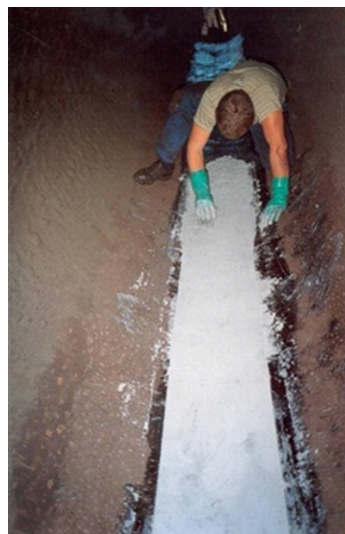
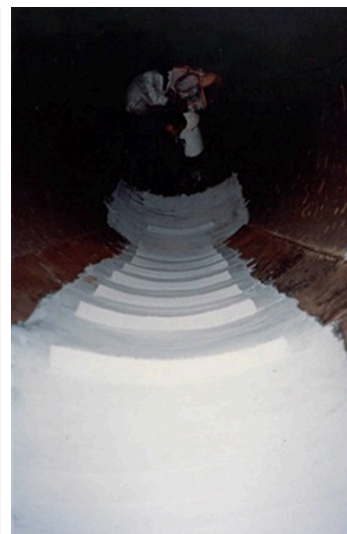
Corrosion and erosion in the lower third of the pipeline caused by abrasion from the millscale .

- * Application of Belzona® 4911 after gritblasting the substrate ,
- * Beginning the application of Belzona® 4111 ,
- * Application in progress ,
- * Creating steps with Belzona® 4111 on a sloping area of the pipeline, in order to facilitate the inspection ,

Following a trial over several months, competing with an alternative solution (which did not last), Belzona 4111 was chosen to protect the lower sections of the pipeline. Its fast cure speed reduced the repair duration. The application was carried out over 5 years: 100m/year (45 buckets/year). After the inspections carried out in 2000, 2001 and in 2002, the product is still in perfect condition. To aid access/application steps were created with Belzona 4111 in a skloping section of the pipeline.
