# SERVICE LIFE EXTENDED: FLYING ASH IS NO PROBLEM FOR BELZONA

ID: 391

Industry: *Power*  
Application: *FBC-Fans, Blowers and Compressors*

Customer Location: *Power Company in the Southwest U.S.A.*  
Application Date: *August 2001*

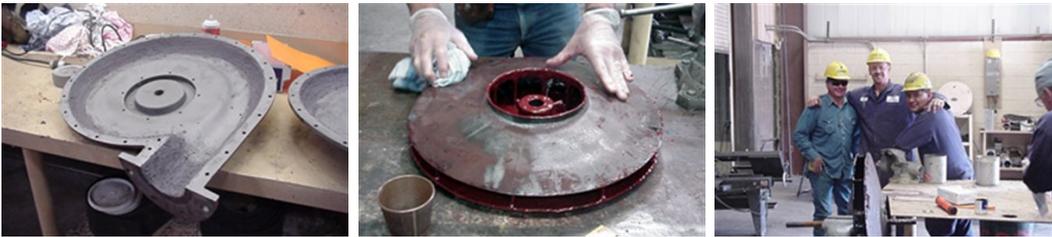
Problem  
*Severe wear*

- \* Worn fan casing damaged from abrasive particles is rebuilt and protected with Belzona® 1812. ,
- \* Fan impeller is coated with Belzona® 2121. ,
- \* The crew is happy with their work. ,

The application was carried out in accordance with Belzona Know-How System Leaflets FBC-2 and FBC-5.

The fan impeller had a life expectancy of 3 months and costs \$1,300. The housing had a life expectancy of one year and costs \$3,000. After one year of service following the Belzona application, the fan was opened up and inspected. The impeller was 90% perfect and the housing was 100% perfect. The impeller was re-coated in June 2003, the housing remains perfect. This application has saved the customer over \$15,000 in less than two years.
