# BELZONA SEALS LEAKING CABLE END BUSHINGS

ID: 3945

Customer Location: Electricity Substation, UK.  
Application Date: June 2012

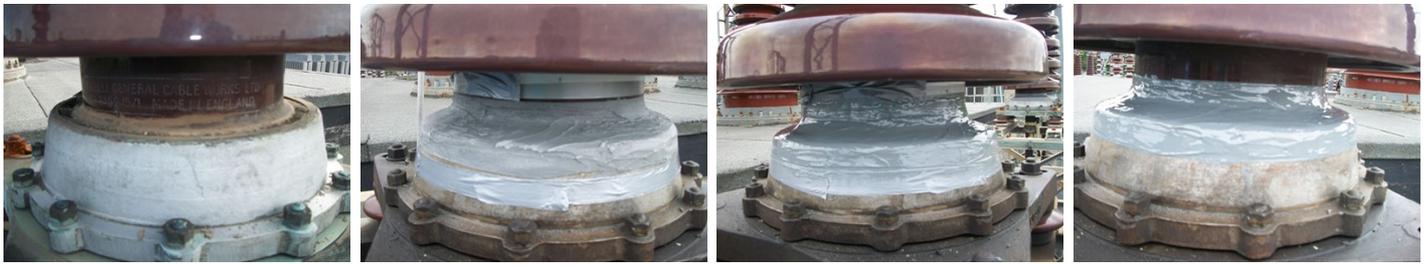
The red phase bushing was leaking oil and the uncontrolled release required sealing. The equipment is aged and the porcelain shed appeared to be fragile and brittle. The Client opted for competitively priced repair as opposed to high cost replacement with a view to extending the asset life.

- \* Original bushing condition ,
- \* Repair area after applying Belzona® 1291, Belzona® 1221 & Belzona® 1161 ,
- \* Final coating with Belzona® 5831 ,
- \* Completed application ,

Cement Joint between porcelain and steel flange disintegrated on three bushings - red, yellow and blue phases.

Application was carried out in accordance with Belzona Know-How System Leaflet VPF-11. After cleaning sand abrading the substrate, Belzona® 1291 & Belzona® 1221 to stem leak between porcelain and steel joint before applying Belzona® 1161 including Reinforcement Tape. Finally Belzona® 5831 was applied to entire repair area.
