DAMAGED FENDER REFURBISHED USING BELZONA® ELASTOMER

Customer Location: Offshore Oil Supply Ship Terminal,
Indonesia

Application: SOS-Ships and Offshore Structures

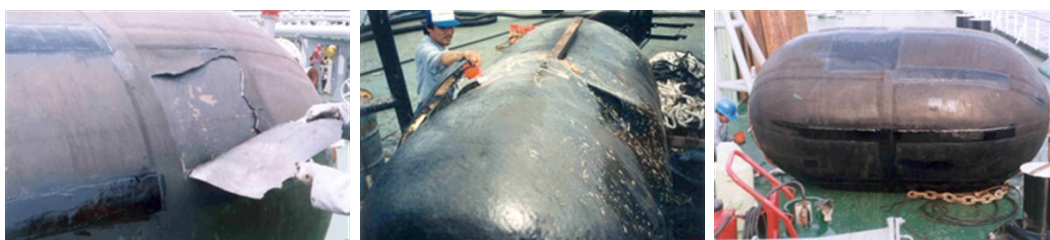
Photograph Descriptions

Severe damage to the surface of fenders. In particular securing chains had damaged the rubber covers through constant abrasion.

- * Damaged rubber being removed. ,
- * Application of Belzona Conditioner. ,
- * Completed application. ,

Application carried out in accordance with Belzona Know-How System Leaflet SOS-12.

Due to their size the ability to make repairs on site quickly with Belzona Elastomers was a major benefit.
