# SCHOOL BUILDING RESTORED WITH BELZONA

**Application:** WPA-Wall Problem Areas

**Customer Location:** Comprehensive School, South Wales

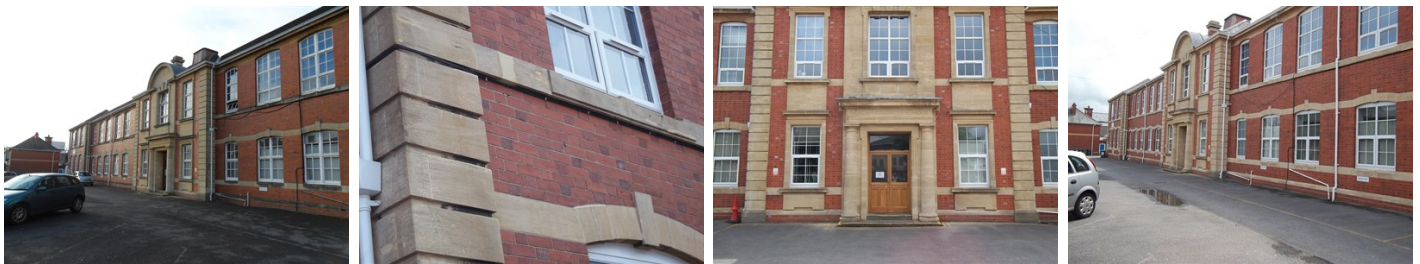
## Photograph Descriptions

The stone work was weathering and the brick work was dirty. In addition there were areas suffering from rainwater ingress.

- \* Front of the school with damaged areas of concrete ,
- \* Damaged areas repaired with Belzona 4141 ,
- \* Application of Belzona 5122 ,
- \* Completed application ,

Application was carried out in accordance with Belzona System Leaflets WPA-4 & 8. The Belzona 4141 was tinted with a cement tone additive to colour match the repair with the Bath Stone and to ensure a visually pleasing repair. The final stage of the application was to overcoat the surface with Belzona 5122.
