# BELZONA ELASTOMER REPAIR TO SEVERELY DAMAGED HOSE

ID: 398

Customer Location: *Dredging Company in Holland*  
Application Date: *October 1987*

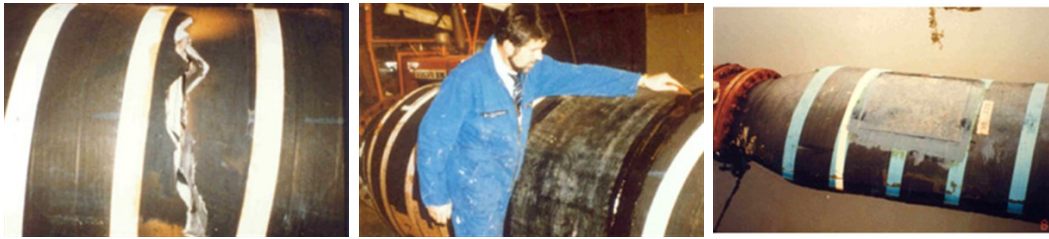
## Photograph Descriptions

*Holes, cuts and tears in the rubber covers of five floating pipes.*

- \* Typical tear in rubber pipe. ,
- \* Application of Belzona® 2111. ,
- \* Floating pipe in service with neoprene patch bonded with Belzona® 2111. ,

Belzona Elastomer repairs offer a rapid solution to torn and damaged floating hoses, at a fraction of the replacement cost. Additional strength was provided in some areas by bonding Neoprene rubber sheets over damaged areas.
