# BELZONA INSIDE A GEAR BOX

Industry: *Pulp & Paper*  
Application: *CEP-Centrifugal Pumps*  
Substrate: *Cast Iron*  
Products: *\* Belzona® 1341 (Supermetalgilde) ,*

Customer Location: *Paper Mill near the Florida panhandle*  
Application Date: *July 1995*

Gear box for pulper tub reducer.

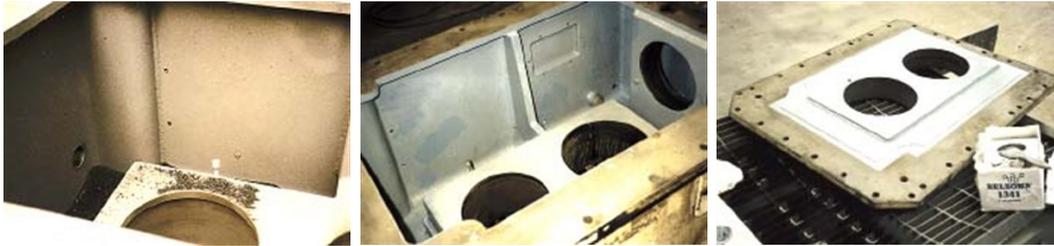
*Corrosion of gear box due to moisture and condensation. Previous internal coatings have failed.*

- \* Internal surface of gear box grit blasted for surface preparation. ,
- \* Inside coated with Belzona® 1341 (Supermetalgilde). ,
- \* The lid of the gear box was also coated. ,

The application was carried out in accordance with a modified version of Belzona Know-How Leaflet CEP-3.

After 2-1/2 years in service, the Belzona coating is in excellent condition. Saving the gear box housing helps protect its expensive gearing and prevents costly downtime. Two gear boxes were coated.
