BELZONA SOLVES DREDGE PUMP WOES

Customer Location: Marine contractor, Panama City, Florida, U.S.A.

Application: CEP-Centrifugal Pumps

Dredge pump repair.

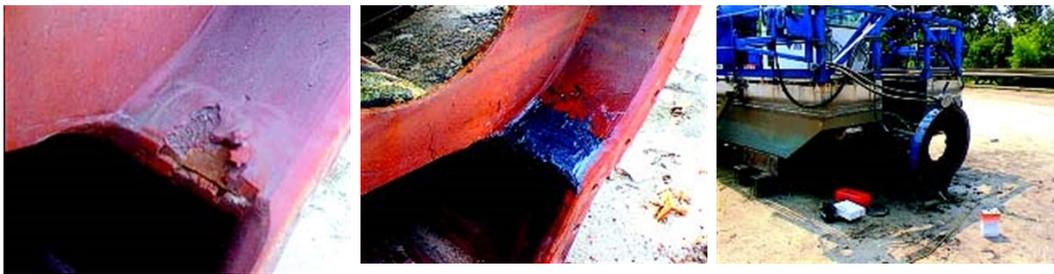
Large roots and stones damaged cutwater and stripped rubber coating from pump.

- * The damage ,
- * Completed repair ,
- * Dredge pump ready for service ,

The application was carried out in accordance with a modified version of Belzona Know-How Leaflet CEP-1.

Application proceeded rapidly using Belzona® 2311 (SR-Elastomer) to achieve full mechanical properties in less than two hours with minimal downtime for the dredge pump operator.
