# BELZONA SOLVES DREDGE PUMP WOES

Application: CEP-Centrifugal Pumps

Dredge pump repair.

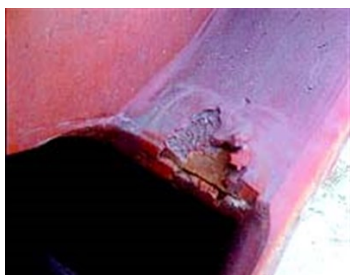
Large roots and stones damaged cutwater and stripped rubber coating from pump.

- \* The damage ,
- \* Completed repair ,
- \* Dredge pump ready for service ,
