PROTECTION OF ACID HOLDING TANK WITH BELZONA

ID: 401

Customer Location: *Nitrogen Plant - Mexico*
Application Date: *February 2002*

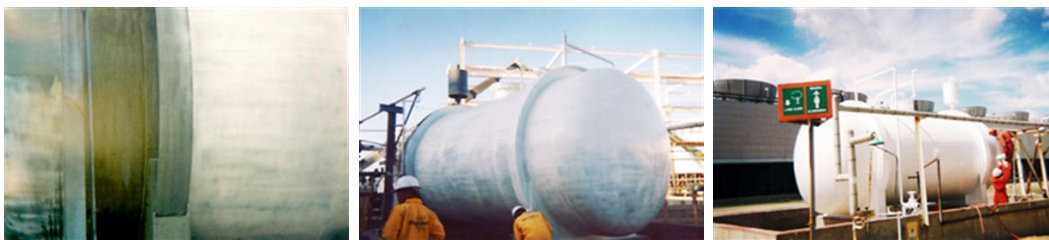
Failure of existing external coating due to the surrounding environment conditions.

- * Corrosion damage on the side of the tank. ,
- * Overall condition of the tank before application of the Belzona coating system. ,
- * Coating application is complete. The system consists of two coats of both the Belzona® 6111 and Belzona® 5111. ,

Continual failure of coating prompted the plant to utilize a proven alternative. The Belzona coating system will not only provide the needed chemical resistance, but it will provide a long-term solution against UV degradation and overall environmental attack.
