# PROTECTION OF ACID HOLDING TANK WITH BELZONA

**Customer Location:** *Nitrogen Plant - Mexico*  
**Application Date:** *February 2002*

Exterior protection of acid holding tank.

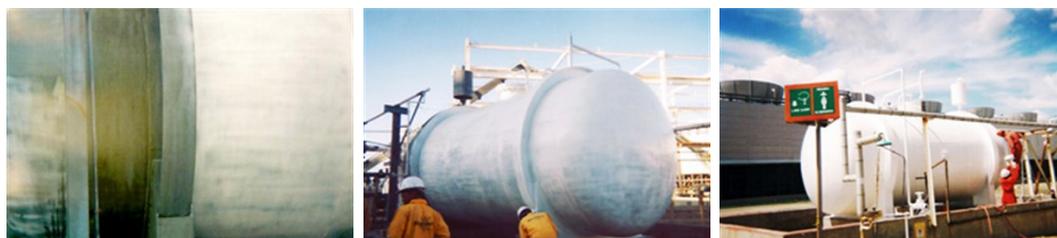
*Failure of existing external coating due to the surrounding environment conditions.*

- \* Corrosion damage on the side of the tank. ,
- \* Overall condition of the tank before application of the Belzona coating system. ,
- \* Coating application is complete. The system consists of two coats of both the Belzona® 6111 and Belzona® 5111. ,

Continual failure of coating prompted the plant to utilize a proven alternative. The Belzona coating system will not only provide the needed chemical resistance, but it will provide a long-term solution against UV degradation and overall environmental attack.
