# BELZONA REPAIRS BALL MILL SHELL

ID: 4025

Customer Location: Cement plant, Al Kawmeya, Egypt  
Application Date: October 2008

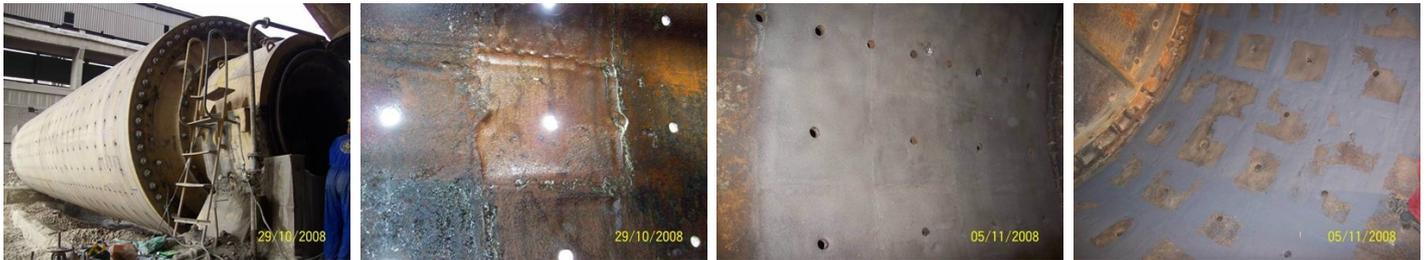
## Photograph Descriptions

Due to the nature of the operation, the internal surfaces of the ball mill are subject to constant impact from the falling balls and other media present inside. Shell wall became damaged beneath the wear plates.

- \* Damaged ball mill ,
- \* Impact damage ,
- \* Surface after preparation ,
- \* Completed application ,

Ball mill shell damaged beneath wear plates.

Application was carried out in accordance with Belzona Know-How System Leaflet SHM-7. After surface preparation, Belzona 1311 was used to rebuild the damaged areas to restore the original dimensions.
