# BELZONA PROTECTS CRUDE OIL STORAGE TANK

**Industry:** General Industry  
**Application:** TCC-Tanks and Chemical Containment Areas  
**Substrate:** Carbon Steel  
**Products:** \* Belzona® 6111 (Liquid Anode),  
\* Belzona® 5111 (Ceramic Cladding),

**Customer Location:** Tank Farm - Mexico  
**Application Date:** August 2001

Exterior coating of 1000-barrel crude oil storage tank.

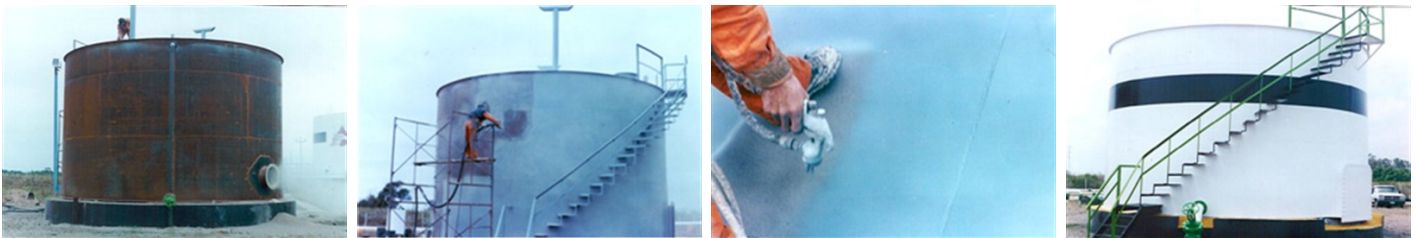
Due to the tank farm's proximity to the coast, a host of components, including abrasion from the sand, salt air, contamination from residual sour gas and other chemical components, contributed to the accelerated erosion/corrosion of the exterior of the storage tank.

- \* Overall condition of the tank before the application of the Belzona coating system. ,
- \* Grit blasting taking place. ,
- \* Application of Belzona® 6111 using spray equipment. ,
- \* View of the tank once the Belzona coating system had been applied. ,

Modified version of Belzona Know-How System Leaflet TCC-5.

The Belzona coating system allowed for the protection of the tank, thereby providing the needed abrasion and chemical resistance.
