# Belzona rebuilds damaged deck floor

ID: 4040

Industry: *Chemical & Petrochemical*  
Application: *FPA-Floor Problem Areas*  
Substrate: *Mild Steel*  
Products: *\* Belzona 1121 (Super XL-Metal) ,*

Customer Location: *Egypt*  
Application Date: *2007*

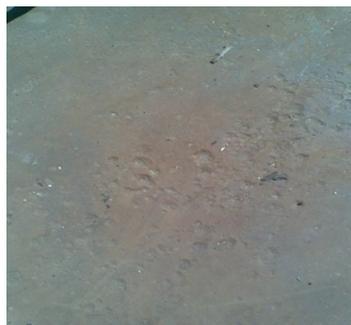
*Severe pitting corrosion had occurred on the deck floor which needed rebuilding.*

Corrosion occurring on deck floor

This was carried out using a modified version of FPA-1. After surface preparation the Belzona 1121 could be applied to restore the deck to its original dimensions.
