Belzona rebuilds damaged deck floor

ID: 4040

Industry: *Chemical & Petrochemical*
Application: *FPA-Floor Problem Areas*
Substrate: *Mild Steel*
Products: ** Belzona 1121 (Super XL-Metal) ,*

Customer Location: *Egypt*
Application Date: *2007*

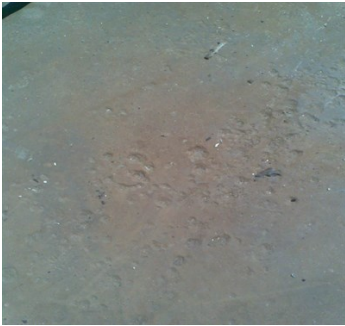
Severe pitting corrosion had occurred on the deck floor which needed rebuilding.

Corrosion occurring on deck floor

This was carried out using a modified version of FPA-1. After surface preparation the Belzona 1121 could be applied to restore the deck to its original dimensions.

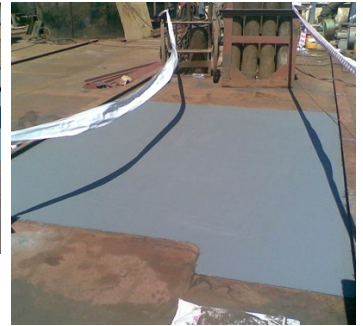
- * 1. Damaged Area ,
- * 2. Surface Preparation ,
- * 3. Belzona 1121 application ,
- * 4. Completed application ,
