# Belzona provides internal corrosive resistant lining

ID: 4041

Industry: Oil & Gas  
Application: TCC-Tanks and Chemical Containment Areas  
Substrate: Carbon Steel  
Products: \* Belzona 5811 (Immersion Grade),

Customer Location: Egypt  
Application Date: March 2006

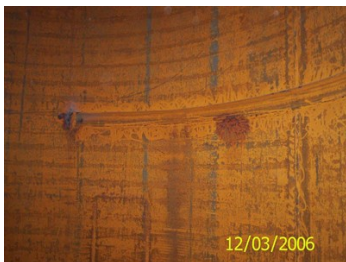
Corrosion occurring on the internal surfaces which needed to be protected.

- \* 1. Corrosion Damage ,
- \* 2. 1st coat successfully applied ,
- \* 3. 2nd coat application ,
- \* 4. Completed application ,
