Belzona provides internal corrosive resistant lining

Industry: Oil & Gas
Application: TCC-Tanks and Chemical Containment Areas
Substrate: Carbon Steel
Products: * Belzona 5811 (Immersion Grade),

Customer Location: Egypt
Application Date: March 2006

Media filter requiring internal lining

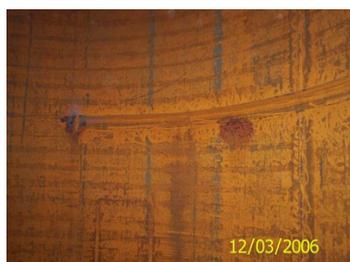
Corrosion occurring on the internal surfaces which needed to be protected.

- * 1. Corrosion Damage ,
- * 2. 1st coat successfully applied ,
- * 3. 2nd coat application ,
- * 4. Completed application ,
