BELZONA INSITU RESTORATION OF SHAFT IN WASTEWATER PLANT

ID: 4047

Industry: Water / Wastewater
Application: MPT-Mechanical Power Transmission

Customer Location: Water treatment plant, Fayoum, Egypt
Application Date: 2008

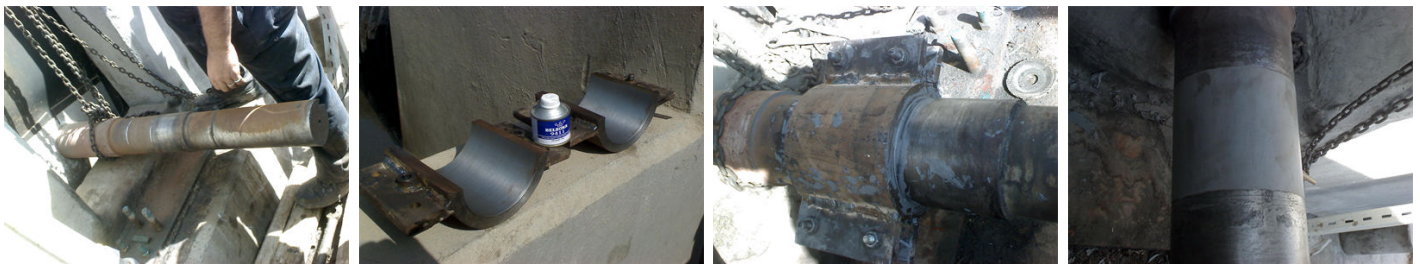
Photograph Descriptions

Shaft had become worn and needed insitu repair.

- * Worn shaft ,
- * Former treated with Belzona Release Agent ,
- * Application with split former in place ,
- * Former removed and shaft ready to be returned to service ,

Damaged shaft on rotary filter at wastewater station

This application was carried out in accordance with Belzona System Leaflet MPT-2.

Repairing shafts using forming technique provides a smoother finish than machining and more importantly can avoid the need to dismantle and remove the plant equipment from its location.
