CO2 ABSORPTION TOWER GETS BELZONA PROTECTION

Industry: *General Industry*
Application: *TCC-Tanks and Chemical Containment Areas*
Substrate: *Carbon Steel*
Products: ** Belzona® 1391 (Ceramic HT),*

Customer Location: *Refinery - Argentina*
Application Date: *October 2002*

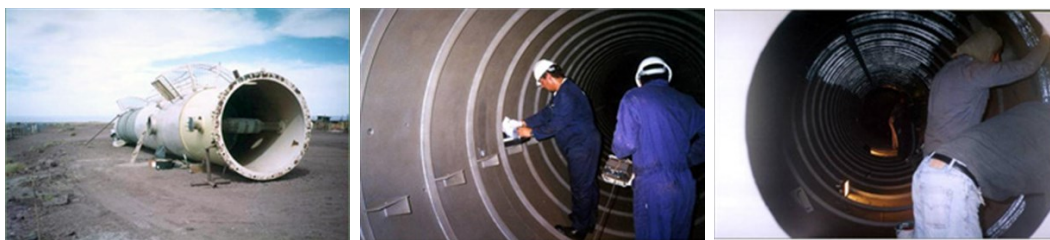
Photograph Descriptions

Severe corrosion on the interior of the tower due to the presence of MDEA and subsequent production of carbonic acid.

- * View of the tower before being taken into a shop for the application. ,
- * A high level of quality control was implemented during the surface preparation phase of the application, as well as with the rest of the job. ,
- * View of the final application. The Belzona® 1391 was applied in two coats. Sandblasting was carried out in between the first and second coat. ,

The use of the Belzona® 1391 afforded the customer a proven coating system that is capable of providing a cost-effective solution resistant to the chemical attack and any possible galvanic effects.
