# BELZONA PROTECTS 4 NEW STERN TUBES

Customer Location: *Leading manufacturer of marine equipment, Spain*

Application: *SOS-Ships and Offshore Structures*

Four newly fabricated stern tubes for naval vessel.

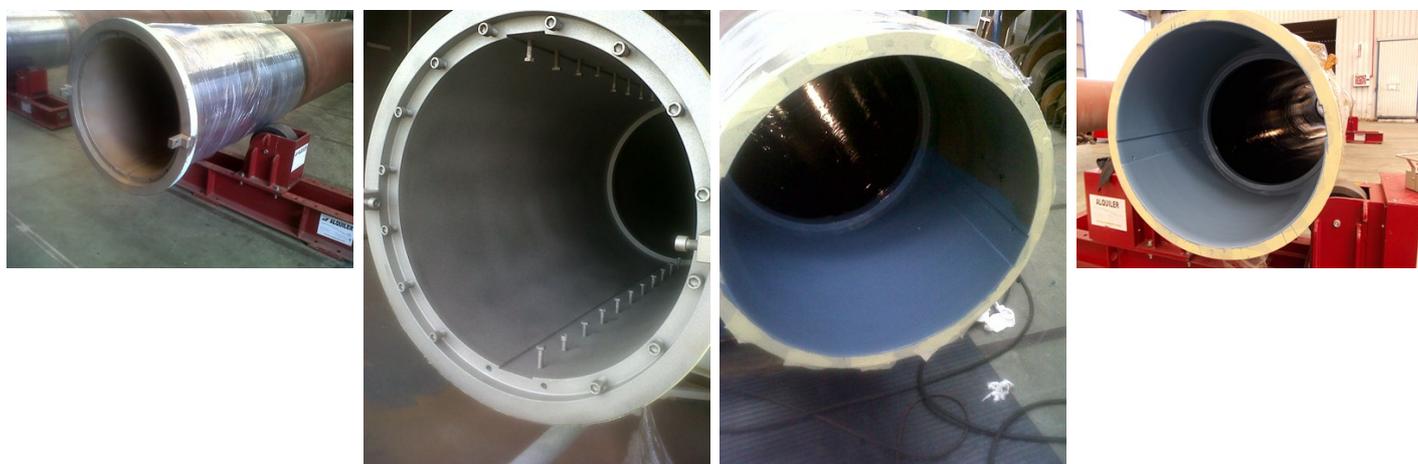
*Erosion and corrosion protection required for the internal surfaces.*

- \* Stern tubes before the application ,
- \* Internal surface of the stern tube grit blasted ,
- \* First coat of Belzona 5811 applied and application of first coat of Belzona 1341 in process to the end section ,
- \* Application completed ,

Application was carried out in accordance with System Leaflet SOS-2. Belzona® 1111 used to fair welds etc. Belzona® 5811 used in central section to provide corrosion protection. Belzona® 1341 used in end sections where erosion is an added factor.
