BELZONA KEEPS HEAVY MACHINERY ON TRACK

Industry: *General Industry*
Application: *MPT-Mechanical Power Transmission*

Customer Location: *Sawmill in Northern California*
Application Date: *November 1998*

Repair wallowed track rail and pads

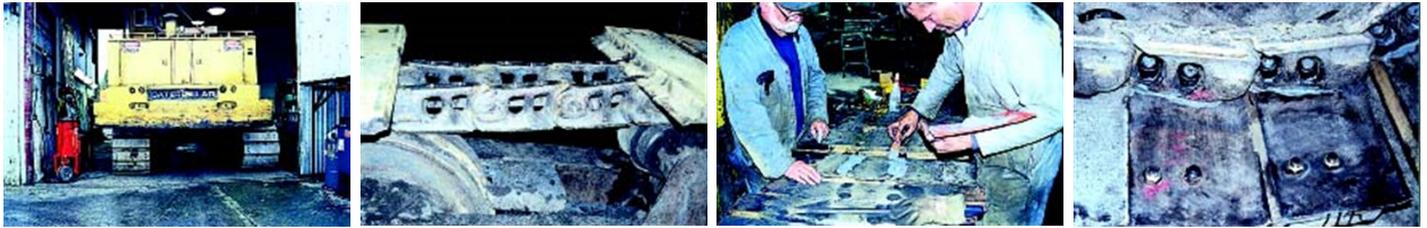
Photograph Descriptions

Track pad bolts were breaking due to excessive wear on rail and pad bolt fit. Excessive bolt replacement costs.

- * Cat 245 grapple ,
- * Rail surface preparation ,
- * Work in progress ,
- * Finished product ,

The application was carried out in accordance with a modified version of Belzona Know-How Leaflet MPT-8.

Customer estimates bolt replacement cost at \$900 per month from broken caterpillar track bolts. Fifteen pads were repaired, bonded to rail, fits repaired on rail. Still intact after eleven months. Repairs continue as bolts break in untreated sections of track rail.
