# BELZONA PROTECTS COOLING WATER SPOOLS

ID: 410

Customer Location: Power station - Ireland  
Application Date: 2003

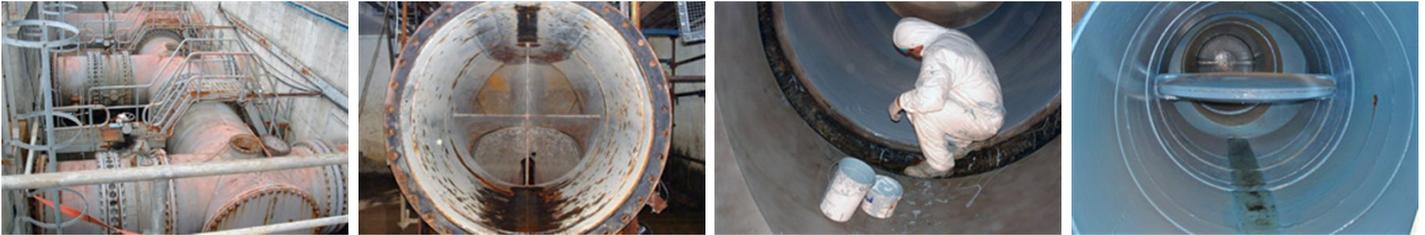
Previous coating was badly damaged allowing severe erosion-corrosion on pipework internals.

- \* General view of the spools ,
- \* Degree of original erosion clearly evident ,
- \* Application underway ,
- \* Completed application ,

Application was carried out in accordance with Belzona Know-How System Leaflet VPF-2.

Some spools were so badly corroded that they had to be replaced or sleeved. The Belzona® 1341 coating will prevent future costly replacement becoming necessary.
