BELZONA REPAIRS TO RUBBER LINED CONDENSER

Industry: Power

Application: HEX-Heat Exchangers

Customer Location: Power station - Ireland

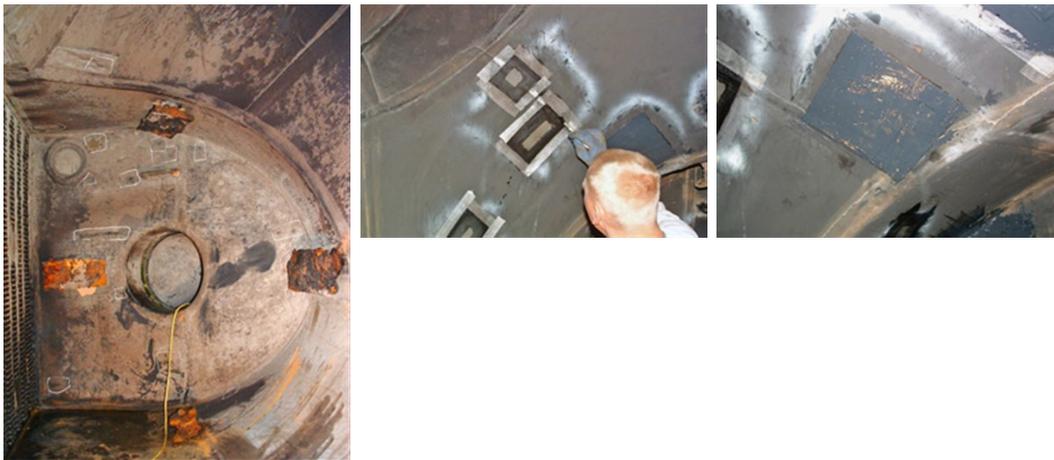
Spark testing of rubber lining highlighted several defects requiring repair.

- * Damaged areas of lining identified and marked ready for repair. ,
- * The repair area masked off to ensure application is kept within prepared area. Conditioner being applied. ,
- * One of the many local repairs completed. ,

Application was carried out in accordance with Belzona Know-How System Leaflet HEX-4. Spark testing identified defects which were then locally repaired.
