# BELZONA® 5851 ON OFFSHORE PIPEWORK

ID: 412

Industry: Oil & Gas  
Application: VPF-Valves, Pipes and Fittings  
Substrate: Rusting Steel  
Products: \* Belzona® 5851 (HA Barrier),

Customer Location: Offshore Oil Company  
Application Date: October 2003

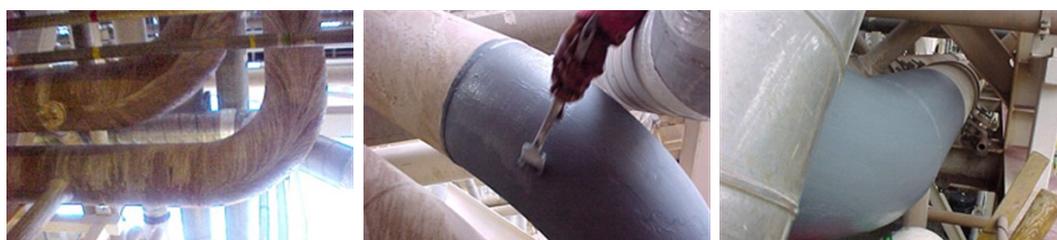
## Photograph Descriptions

The presence of insulation around the heating medium pipework had led to some corrosion of the pipework over a period of time. During a routine inspection it was decided that applying Belzona® 5851 whilst the pipework remained in service represented the best option to prevent future corrosion.

- \* Corrosion to heating medium pipework ,
- \* Application of first coat of Belzona® 5851 ,
- \* Completed application ,

Corrosion Under Insulation (CUI) on heating medium pipework.

The pipework was wet-blasted, allowed to dry and any residual aggregate brushed off. Some flash rusting was evident, and considered acceptable prior to application of two 250 micron coats of Belzona® 5851.
