BELZONA KEEPS DUST SUPPRESSION BOWSER IN SERVICE AT QUARRY

ID: 4130

Customer Location: Limestone quarry, SW, England
Application Date: September 2012

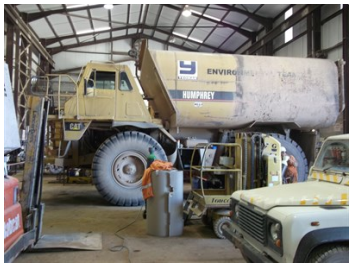
* Quarry dust suppression bowser in workshop Damage and Corrosion to be repaired Initial application of Belzona® 1111 Finished application. Cure accelerated by heat ,

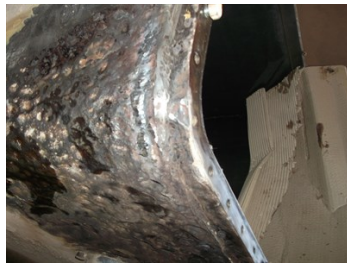
Dust suppression bowser had suffered damage and corrosion to its hydraulic tank causing leakage.

Traditional welding repair had failed to seal the tank. The customer required a fast cold curing solution to bring the bowser back into service.
