BELZONA BONDS SPADE RUDDER BEARING ON COASTER

Application: SOS-Ships and Offshore Structures

Spade rudder bearing on coastal ship.

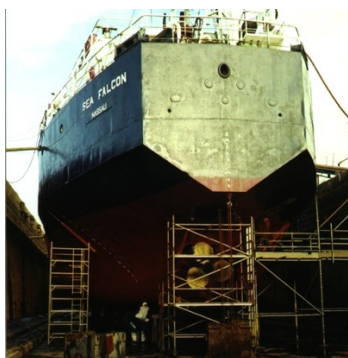
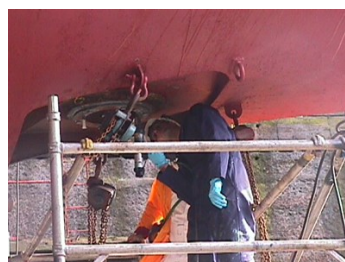
Significant Galvanic Corrosion - from 3 to 7mm had occurred, causing the bronze bush to be unsupported. This was a spade rudder and the forces on the bearing were great.

- * Vessel prepared for works in drydock ,
- * Top of bearing sealed using Belzona® 1221 ,
- * Injection of Belzona® 1321 into the space ,
- * Completed works. The injection plugs are removed at the same time as the rudder is assembled. ,

Application was carried out in accordance with Belzona System Leaflet SOS-9. The top of the bearing was sealed using the Belzona® 1221, and, due to the overhang over the top of the bearing, capillaries were set in to ensure good venting during the injection process.

All works were carried out within one day and witnessed by the Lloyds Register Surveyor. 12 kg of Belzona® 1321 was required to

secure the bearing into position, providing a 100% contact between the bearing and the housing, and compressive load bearing capability significantly above the 10N/mm² required.
