# Belzona seals roof over production area

ID: 4158

**Customer Location:** Manufacturer, UK  
**Application Date:** September 2012

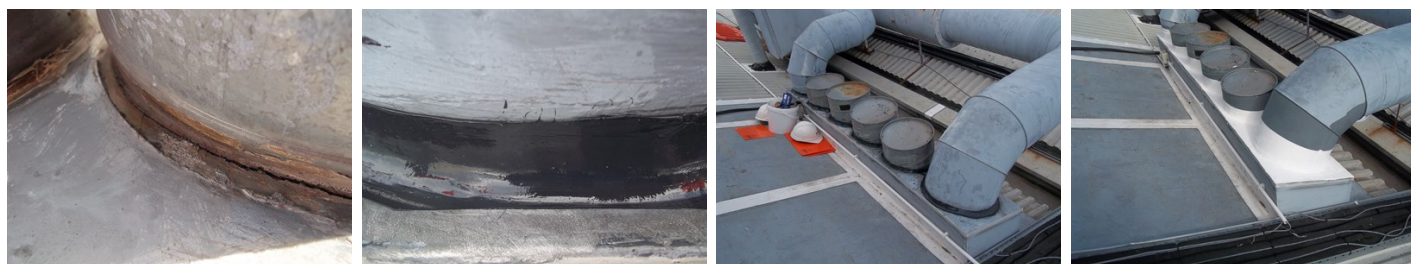
The effect of weather and UV caused rubber seals around ductwork penetrations to degrade allowing rainwater to leak directly into the production area creating disruption in production and safety issues.

- \* Deteriorated joint ,
- \* Belzona® 2211 applied to seal gap ,
- \* All joints sealed with Belzona Elastomer ,
- \* Fully Reinforced Belzona® 3111 system applied to give additional sealing and protection ,

Application was carried out in accordance with Belzona Know-How System Leaflet RPA-1 and 6. The joints were resealed with Belzona Elastomer, before applying a fully reinforced Belzona® 3111 Flexible Membrane system.

Belzona system was applied in 2 days without disrupting production, giving a long term water and weather resistant solution.
