BELZONA CREATES SAFE ENTRANCE FOR WORKERS AND VISITORS

ID: 4175

Customer Location: Building materials manufacturer, Croatia
Application Date: October, 2012.

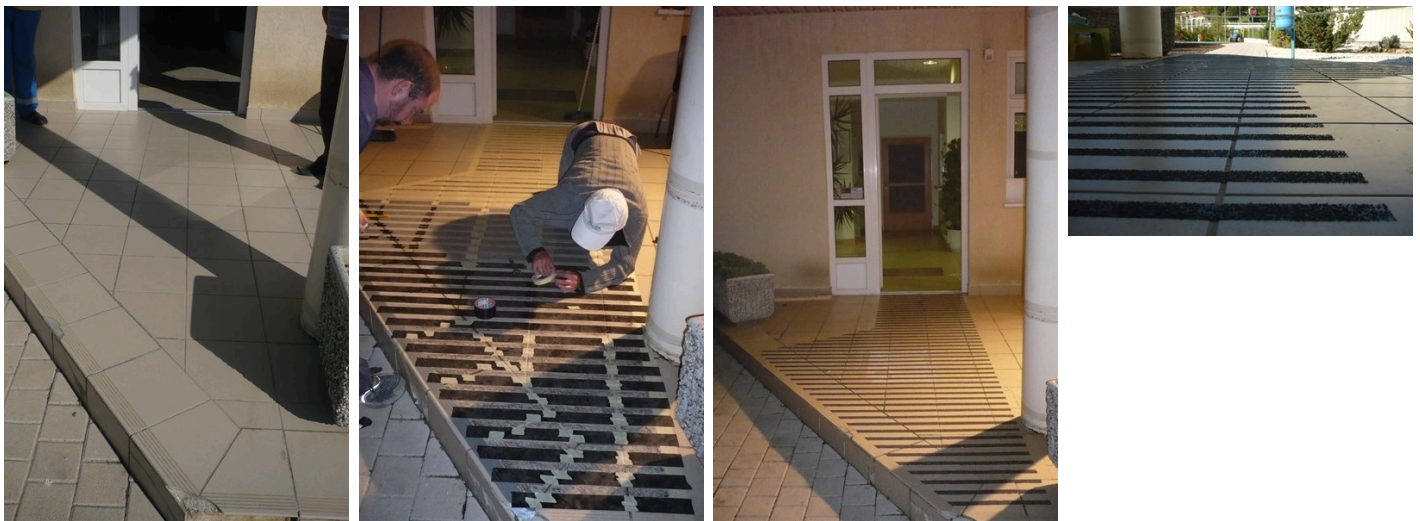
New quarry tiled floor at the entrance to the factory reception was extremely slippery when wet. This identified slip hazard had to be made good by the client.

- * New quarry tiles that are very slippery when wet ,
- * Application in progress - creation of pattern ,
- * Application finished ,
- * Application finished - close up shot ,

Application was carried out in accordance with Belzona Know-How System Leaflet FPA-8.

Belzona provided an acceptable and cost effective solution. Application was carried out late in the evening, in order not to disturb customers during his operating hours. In the morning the floor was ready. Belzona solution eliminated the trip hazard and provided durable and nice-looking non-slip system. The expensive alternative was to replace the quarry tiles.
